# Spur Gear Wear Investigated in Support of Space Shuttle Return-To-Flight Efforts

As part of NASA's Return-To-Flight efforts, the Space Operations Program investigated the condition of actuators for the orbiter's rudder speed brake. The actuators control the position of the rudder panels located in the tail of the orbiter, providing both steering control and braking during reentry, approach, and landing. Inspections of flight hardware revealed fretting and wear damage to the critical working surfaces of the actuator gears. To best understand the root cause of the observed damage and to help establish an appropriate reuse and maintenance plan for these safety critical parts, researchers completed a set of gear wear experiments at the NASA Glenn Research Center.

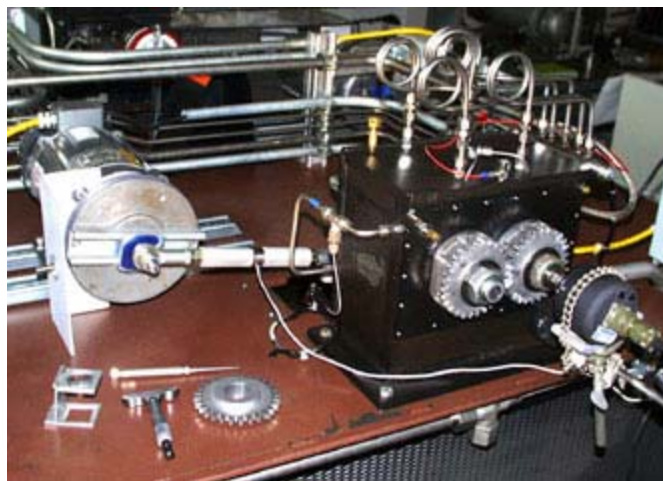
*Glenn's Spur Gear Test Rig setup for gear wear experiments.*

Long description of figure 1. The Spur Gear Test Rig is a torque-regenerative type rig driven by an electric motor to cause a back-and-forth dithering motion for gear wear experiments.

Wear of sufficient magnitude can weaken the strength of a gear tooth, particularly if the hardened surface layer is worn thin. Furthermore, gear tooth wear can accelerate other modes of failure, such as surface pitting fatigue. In addition, wear and pitting debris can be detrimental to the proper operation of bearings within the gearbox. An assessment of technical literature reveals that accurate predictions of gear wear require dedicated laboratory experiments that closely duplicate the gear tooth loads, motions, material, surface topography, and lubrication method for the particular application. A set of gear wear experiments were performed to support the assessment of space shuttle rudder speed-brake gearing. The experiments were completed using Glenn's spur gear test rigs. In the past, these rigs were used to study the performance of high-speed, oil-lubricated gears. The rigs were modified to provide grease lubrication, low-speed operations, and direction reversal (dithering motions), like that which occurs within the orbiter's rudder speed-brake actuators (see the photograph).

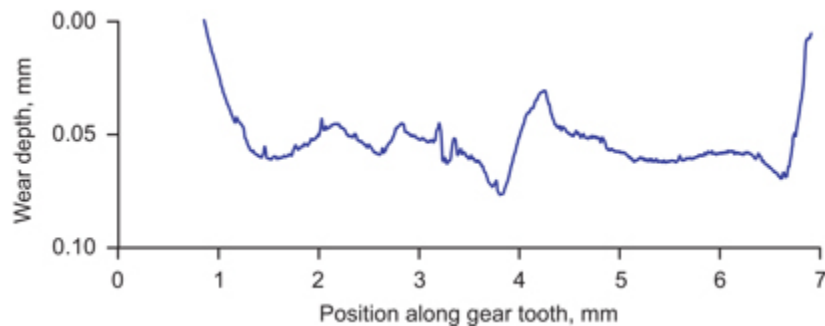
*Typical gear wear trends and depths for gear tooth positions from low on the tooth (1-mm position) to high along the tooth (7-mm position). The wear shown occurred after 80,000 gear dithering cycles and torque producing a 1.1-GPa (160-ksi) hertzian contact pressure at the pitch-line position on the gear.*

Long description of figure 2. Wear depth in millimeters versus position along gear tooth in millimeters. The wear profile shows peaks and valleys on the order of 0.5 mm wide and 0.05 mm deep.

Gear wear was measured with high accuracy by employing a stylus profilometer using a specially devised fixture that allowed accurate mounting and orientation of the gear on the measuring machine. In this manner, profile traces of new and worn gear teeth were compared and processed using a computer algorithm to determine wear amounts. A plot of typical wear data (see the next graph) shows how the wear depth varies along the tooth profile. One important measure of the severity of gear wear is the maximum wear depth. The final graph summarizes the measured maximum wear depths as a function of gear operating cycles.

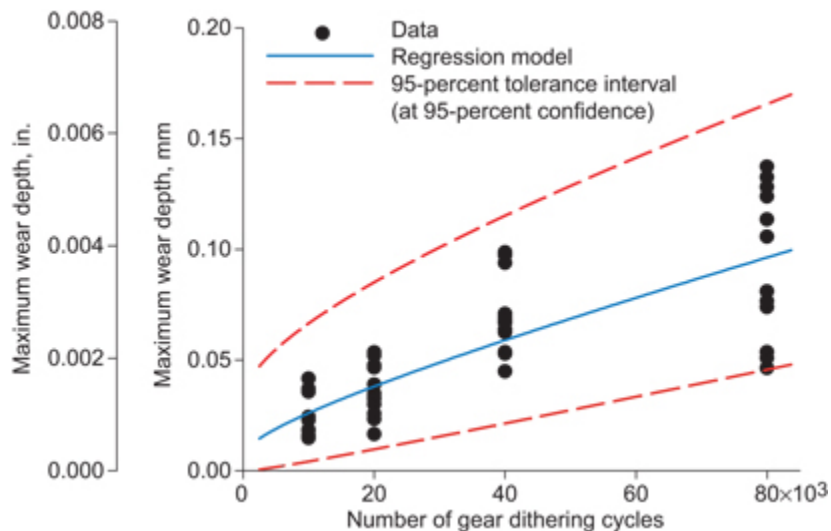
*Test results for spur gear wear, including regression model and statistically based tolerance interval.*

Long description of figure 3. Graph of maximum wear depth in inches and millimeters versus number of gear dithering cycles for data, regression model, and 95-percent tolerance interval (at 95-percent confidence). Wear depths on the order of 0.10 mm occurred after 80,000 gear-dithering cycles. The trend of wear was approximately linear with depth. The statistical 95-percent tolerance band at 95-percent

confidence shows an anticipated scatter band for a large population of parts that is nearly equal to the mean value.

The data were modeled to provide intervals to capture the likely range of wear amounts that can be anticipated for a large population of parts operated in identical fashion. The data show an approximately linear trend for the range of cycles and wear depths investigated, an important finding that will provide confidence in projecting wear rates for gears that are proposed for inspection, assessment, and potential reuse on space shuttle orbiters. This work was completed as part of the NASA Engineering Safety Center's Independent Technical Assessment of Orbiter Rudder Speed Brake Gear Margins.
